# **Linhay Hill Quarry Local Liaison Group**

## **Notes of Site Visit**

**Date and Time:** 2 July 2025  
10am

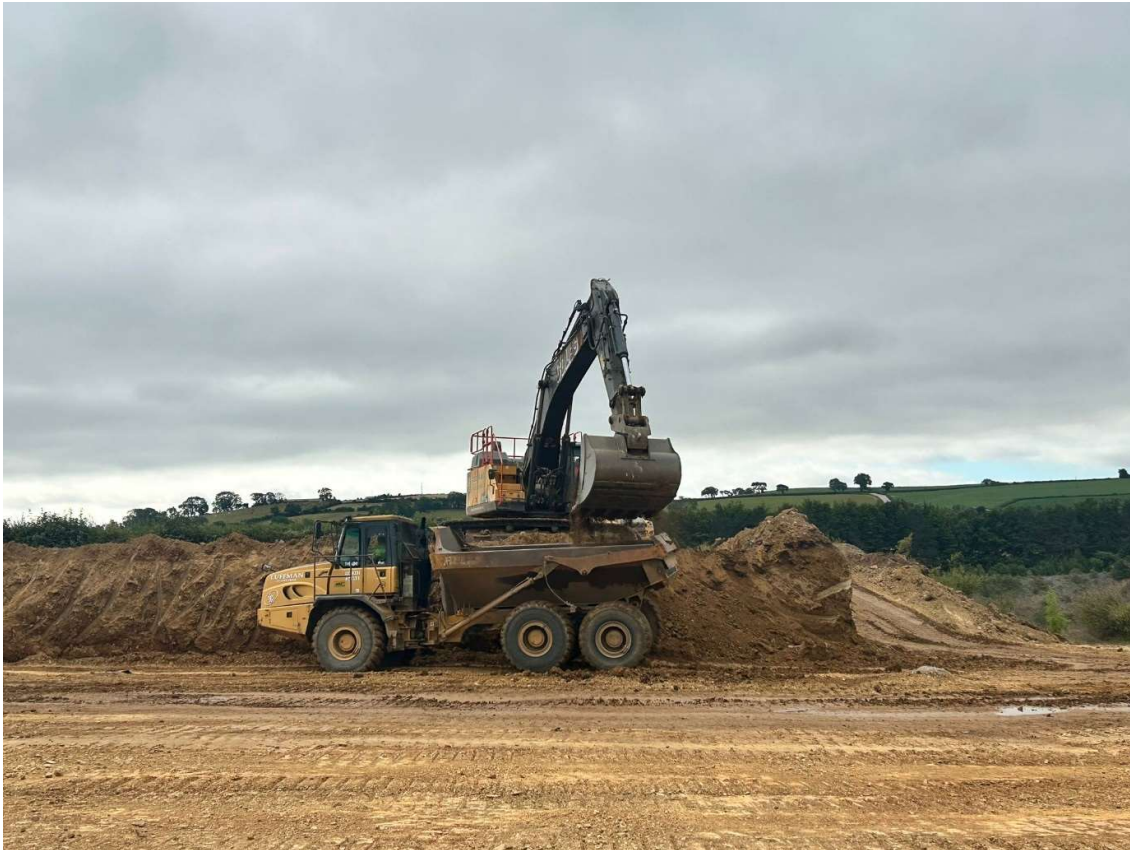
The excavator is positioned on the undug surface, whilst the dump trucks are loaded whilst parked down on the stripped layer, which is a more efficient arrangement. The photo shows a dump truck being loaded in this way.

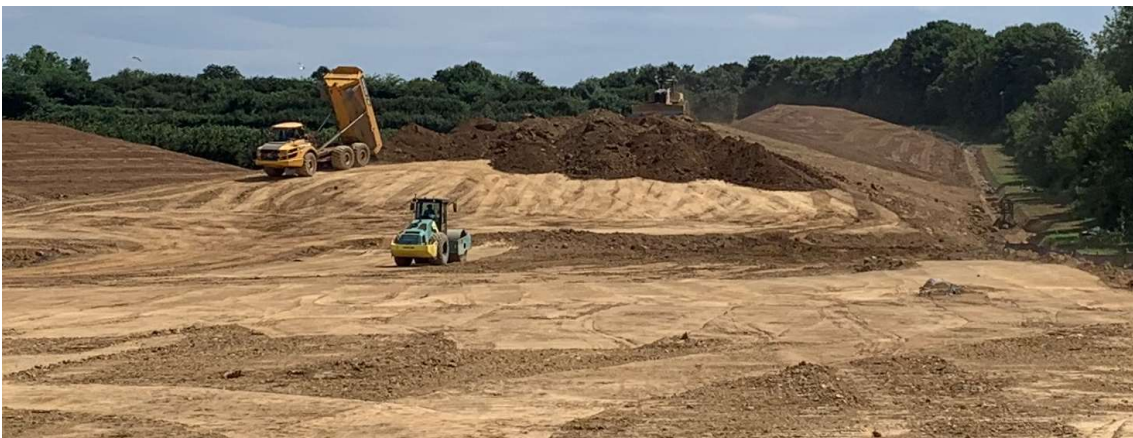
The westernmost section was about a third completed, so visitors could see the whole bund building process, with the topsoil already stripped from the bund footprint and stored alongside, followed by the surface of the footprint being 'keyed in' ready to receive the overburden itself. The bund is being built progressively westwards in layers of approx. 0.5m thickness. The dump trucks drop the overburden on the active front of the bund and the layers are smoothed with a dozer and compacted with a roller, as can be seen in the photo below.

A dump truck has just dropped its load, and the dozer is starting to level the heaps of overburden. The roller is in the foreground, getting ready to compact the levelled surface. The completed section of bund is visible in the background.

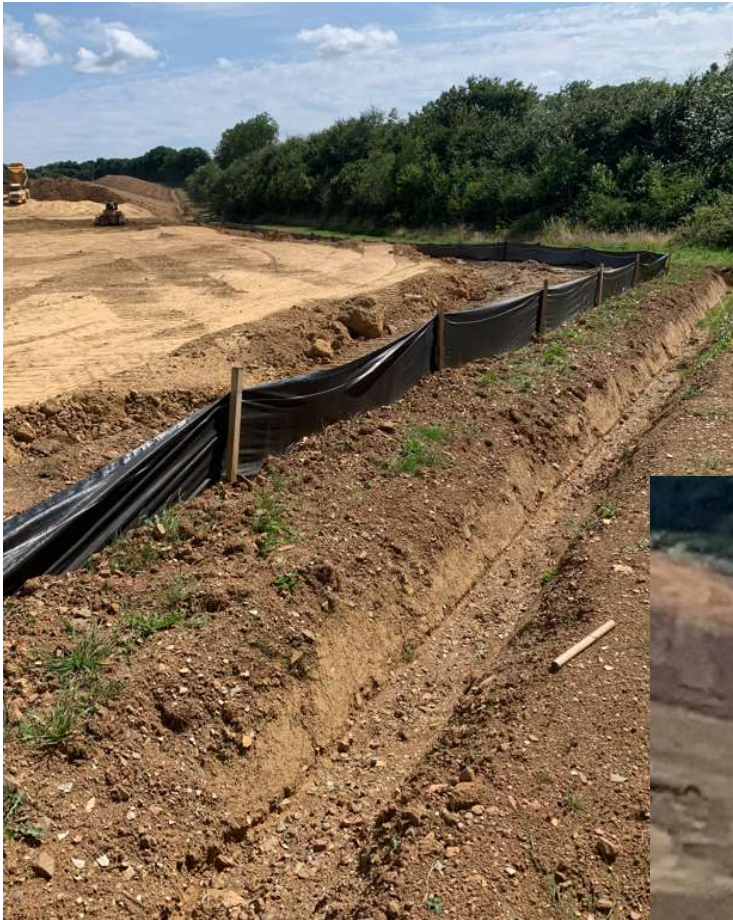
Barry pointed out the perimeter surface water drainage ditch visible on the right-hand side of the above photograph and shown in more detail below:

The ditch is protected by a temporary plastic fence to prevent overburden spilling into it whilst the bund is being built.

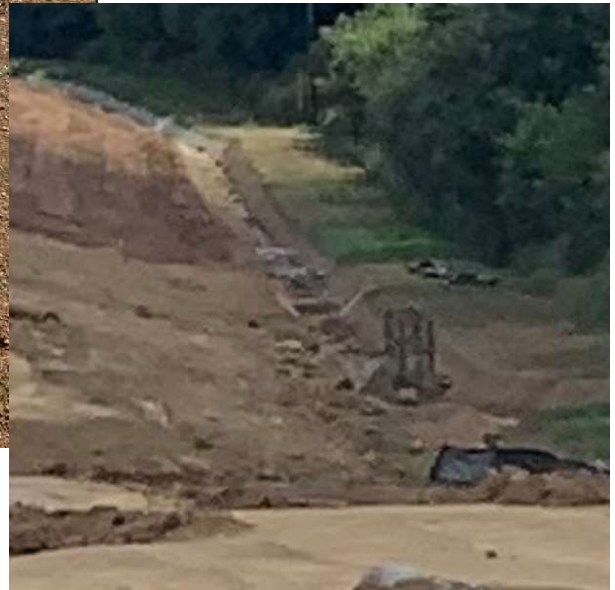
On the steeper ground in the distance, leaky stone dams and bales of straw have been placed in the ditch to slow the flow of water to reduce scouring.

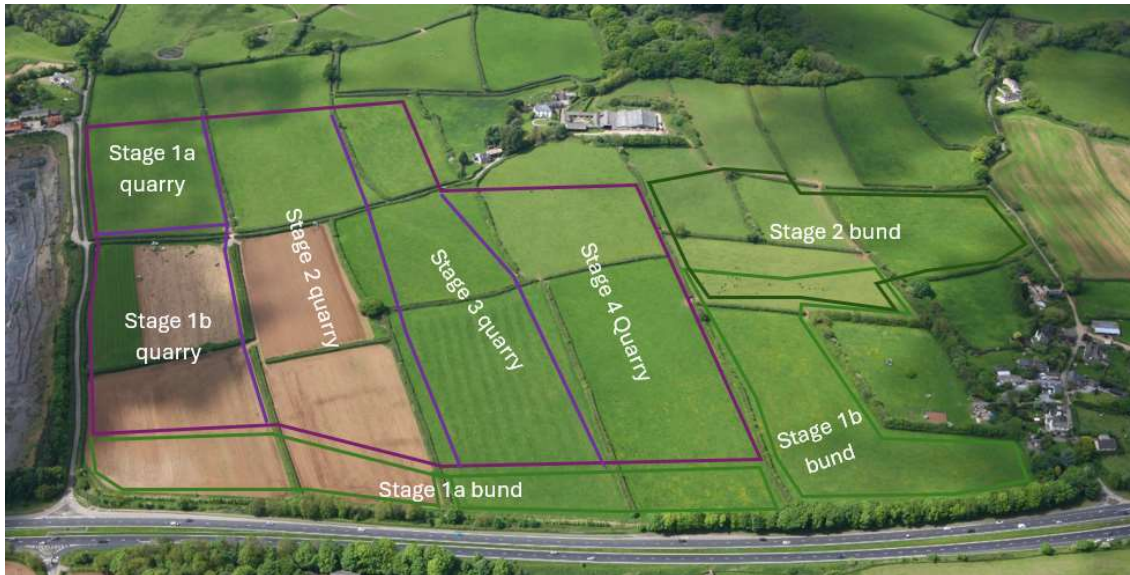
The approximate footprints of quarry extension Stages 1 to 4 and associated bunds for Stages 1 and 2 are illustrated in the diagram below.
